TCEQ DAM SAFETY
Field Operations Support Division

Dam Evaluation Report

Hearn Dam

TX09407

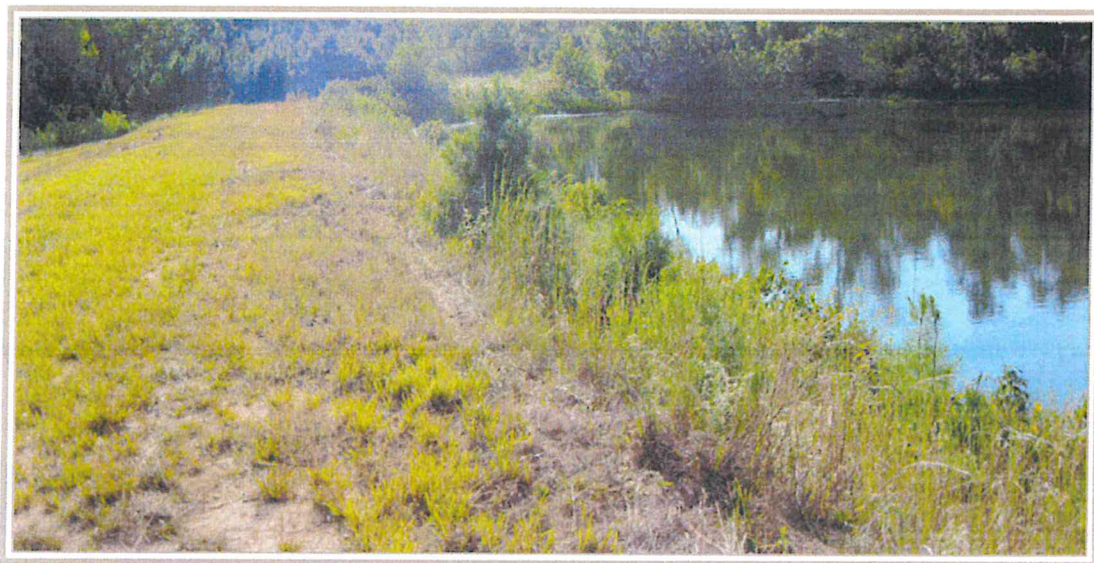
- The upstream slope had tall, dense vegetation – weeds, brush, a few small trees - growing on the slope. See Photo 1.
- In the locations where the upstream slope was more thoroughly investigated, the slope was even and no deficiencies were noted in the embankment itself.
- Several animal trails, possibly beaver 'slides,' were observed running down the slope, but no other obvious beaver activity was observed. The trail with the most damage to the embankment is shown in Photo 2.

Photo 1 - Upstream slope and crest.

3. Debris, brush, and trees (less than 4" diameter) should be removed from the entire embankment, including the crest, upstream, and downstream slopes, and from the downstream toe. Trees larger than 4" diameter, if any, may remain until their death, at which time the tree and roots should be removed and resulting hole(s) backfilled with properly compacted clay. Removal of larger trees and backfill repairs should be supervised by a professional engineer with dam experience. All brush and woody vegetation should also be removed from the service and emergency spillways. After tree removal and hole repair, a proper grass cover should be reestablished.

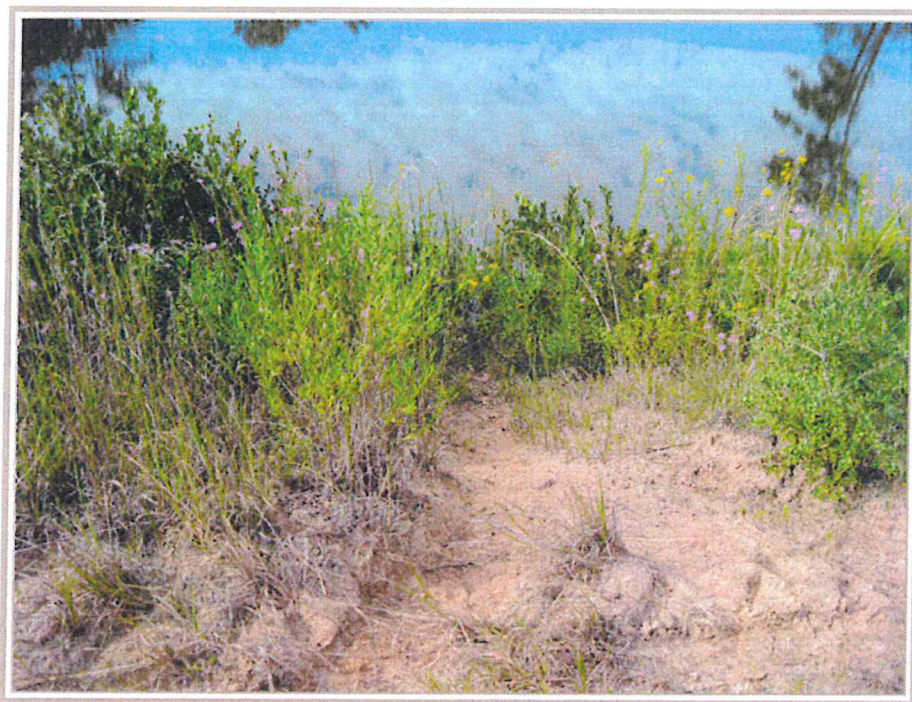
Photo 2 - Animal trails on the upstream slope. Several other trails were seen, but this one has by far the greatest amount of damage.

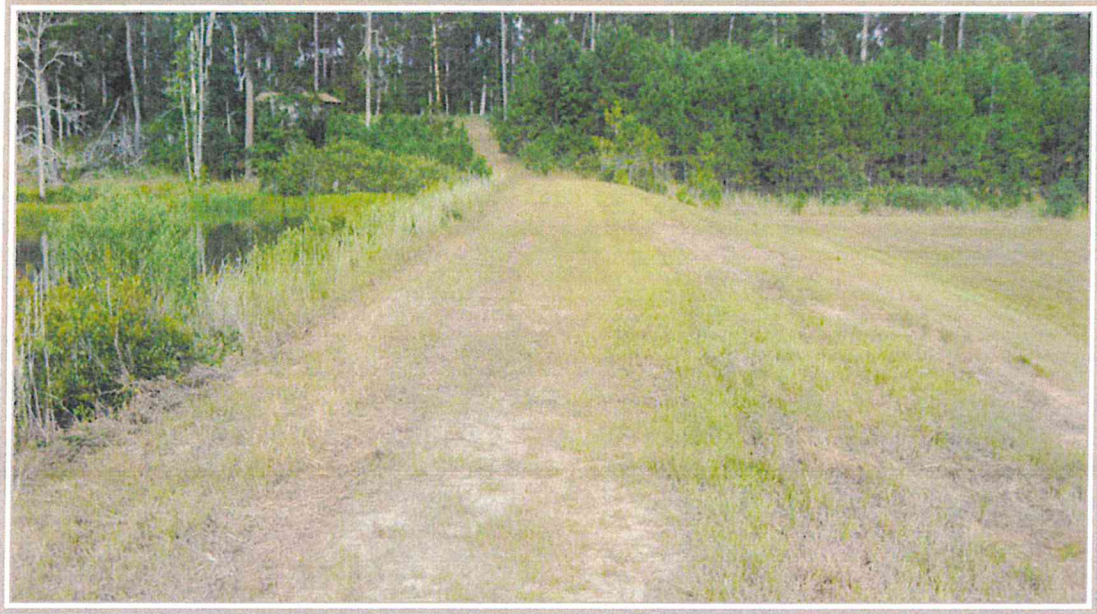
- The crest appeared to be level right to left with a crowned appearance upstream to downstream.
- The crest had a sparse grass cover. See Photo 3.
- The crest was measured with a survey rod at one location to be about 11 feet wide.
- The crest was paced off at one location to be 16 feet wide.
- The crest was paced off to be approximately 210 feet long.
- The crest was of a sandy material.
- Fire ants were noted.
- Evidence of vehicle traffic on the crest was noted.

Photo 3 - Typical condition of the crest.

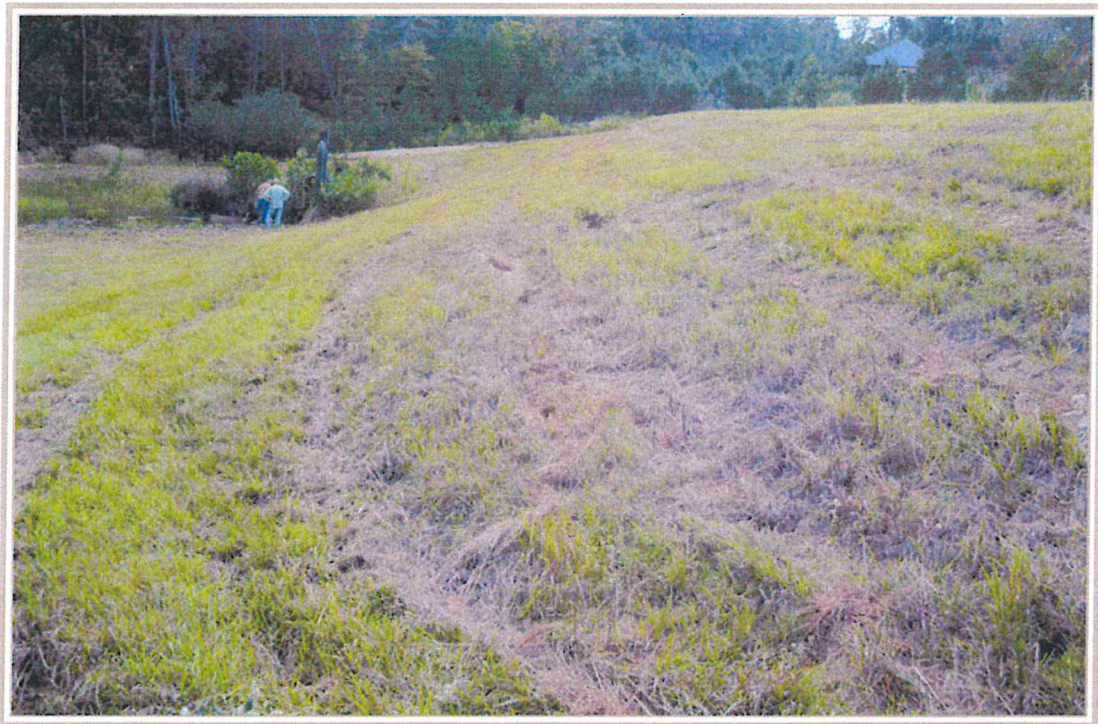
- The downstream slope had a short, recently mowed grass cover. Coverage was fair with a few bare spots. See Photos 4.
- The approximate slope was between 2.5:1 and 3:1.

Photo 4 - Downstream slope from the left. Individuals are standing at the outlet pipe structure.

9. An operation and maintenance plan is required for all dams (30 Texas Administrative Code, §299.43). The plan should include maintenance for all grassy surfaces on the embankment and the area within ten to fifteen feet of the toe. Maintaining a 6-inch grass cover provides an ideal surface to protect against erosion, to limit suitable habitat for burrowing animals, and also to allow for easier detection of developing problems. Irrigation may be necessary to maintain this grass cover. The plan should include clearing vegetation and debris from the lake's water line, from the spillways, and from around the outlet pipe structure. The plan should include annual operations of all mechanical equipment. If mechanical equipment has

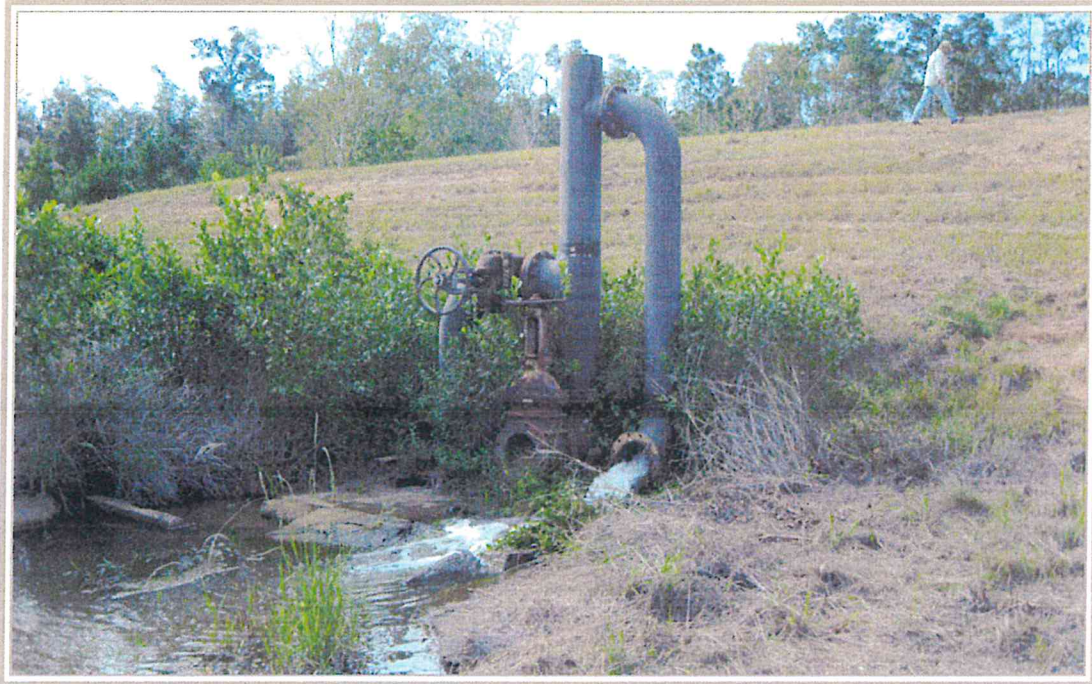
- The service spillway consisted of a 12-inch steel pipe through the embankment with valving that allows three different water levels.
- The outlet pipe structure was in good condition. It was reported that both valves are regularly exercised.
- Heavy brush was growing on the west side and just upstream of the outlet pipe structure. See Photo 5. Possible animal activity was observed in this brush in the area just up-slope from the outlet pipe structure.

Photo 5 - Outlet pipe structure. Both valves were reported to be operational.

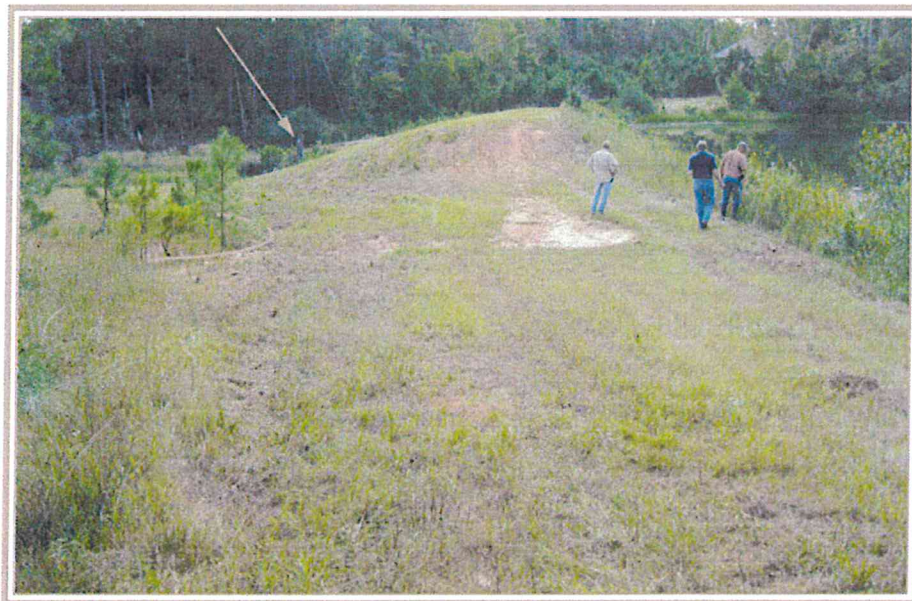
- Photo 6 shows that the typical low brush seen at the water line along the upstream slope continues across the upstream edge of the emergency spillway.
- The earthen emergency spillway had a bare spot at the crest. See Photo 6.
- The erosion shown in Photo 7 was just downstream from the crest. This eroded surface was in approximately the same location as the erosion reported in the 2001 inspection. Based on available photographs, the current erosion is estimated to have less aerial extent than that observed at the 2001 inspection. The erosion shown in the 2001 inspection report did not appear to have as pronounced of a headwall as the erosion observed at this inspection. It is estimated the maximum height of the headwall was approximately 18 inches.

Photo 6 - Emergency spillway. The small pine trees in the upper left are at the erosion seen in Photo 9. The arrow is pointing at the outlet pipe structure.

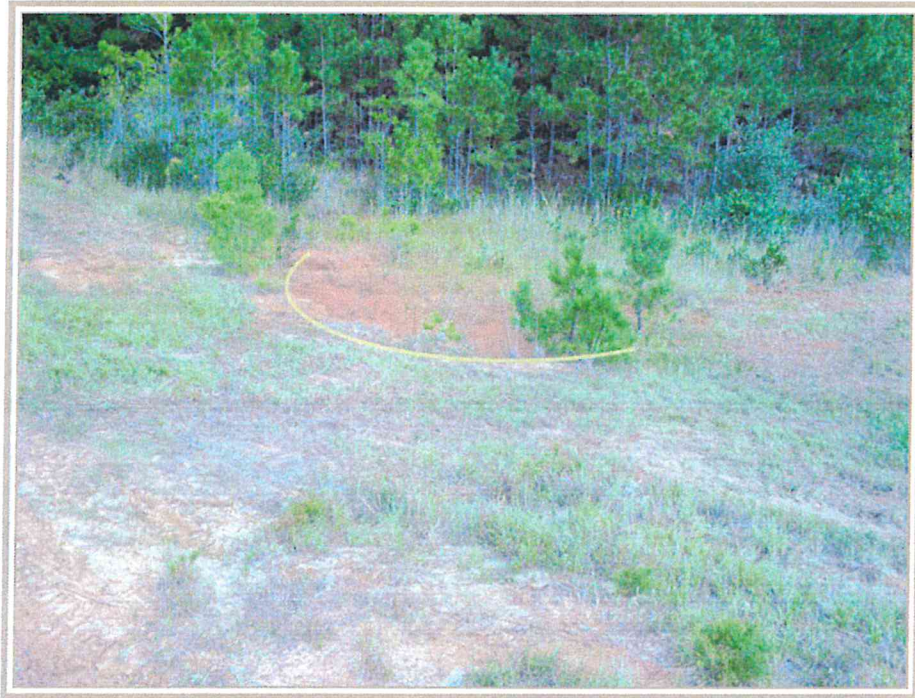
Photo 7 - Erosion in the emergency spillway.

8. Erosion in the emergency spillway should be repaired, because it may progress back to the reservoir with each engagement, eventually leading to loss of the reservoir if left uncorrected. Excessive velocities in the spillways can be corrected through proper spillway sizing for the required design storm (see Rec. 10)

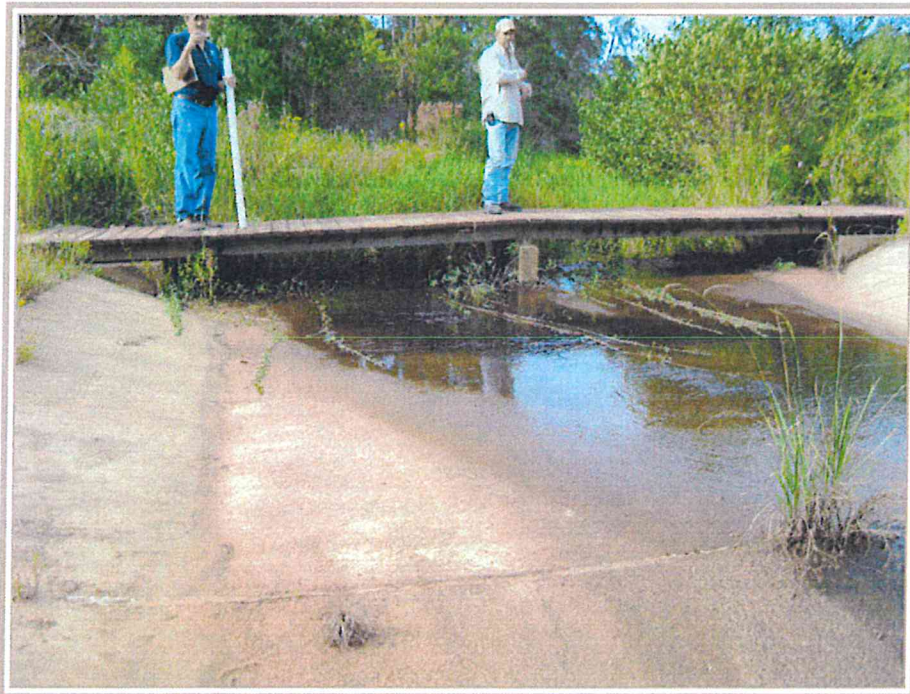
- The concrete spillway at the right end of the dam was minimally engaged. See Photo 8.
- The bottom width of the concrete spillway was paced off at 14 feet.

Photo 8 - Upper end of right spillway.

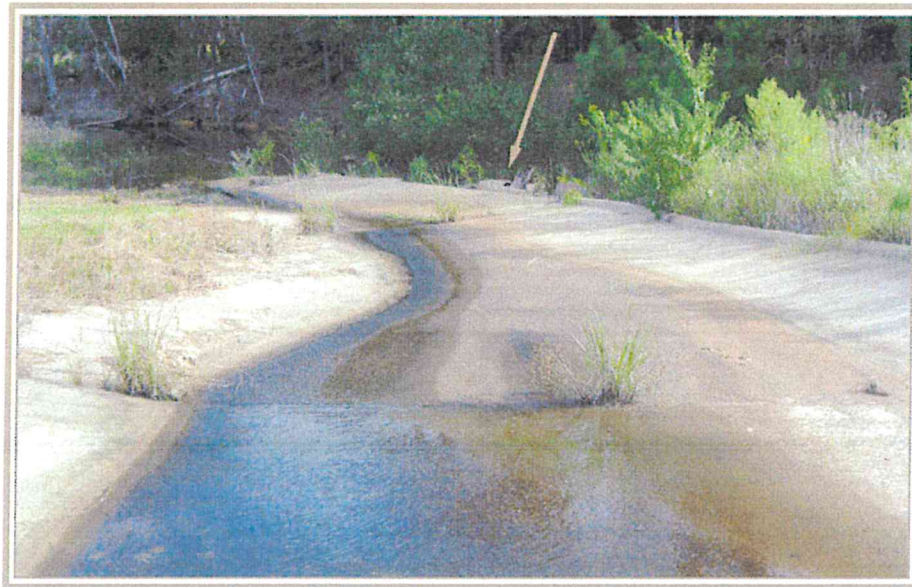
- Grass was growing out of construction joints in the upper and lower sections of this spillway. These construction joints appeared to be open and appeared to be allowing water to flow into the area beneath the concrete. See Photo 9.

Photo 9 - Upper section of the right spillway. At the construction joints, an abrupt change in the width of the flowing water can be seen.

4. As part the spillway repair, joints should be cleared of vegetation and grout replaced.
5. Once the upstream slope is clear of woody vegetation, the slope should be inspected by a Professional Engineer to determine if slides and/or benching are occurring. Proper repairs to these problems should be developed and implemented under the supervision of a Professional Engineer.

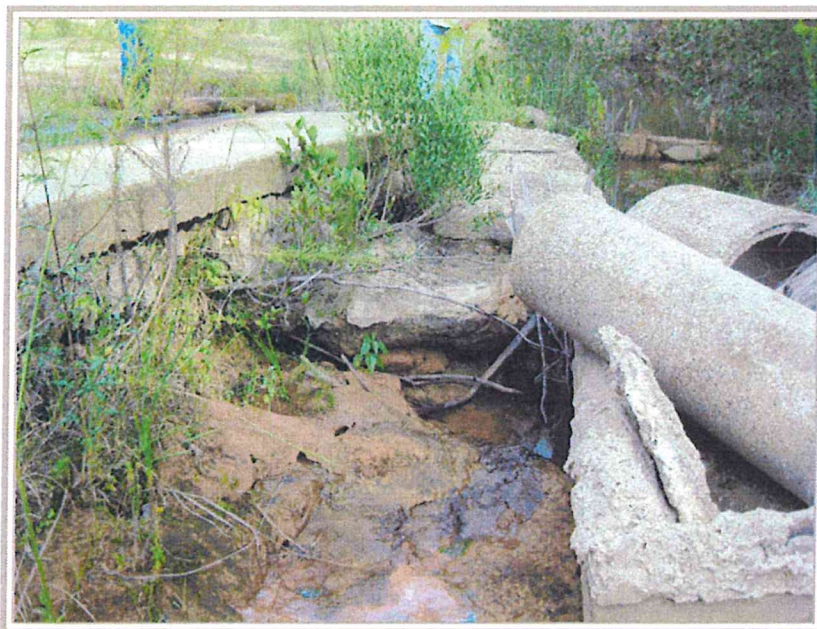
- Photo 10 shows the area to the right of the lower end of the concrete.
- What appeared to be a rather extensive void was found beneath the concrete of the lower section of the concrete spillway. Photos 11 shows what appears to be the reinforcing rod exposed at the bottom of the concrete slab. And in another nearby location, Photo 12 shows another void or perhaps the same void approximately 25 feet further upstream from the location of Photo 11.

Photo 10 - Right edge of the right spillway at its lower limit. The edge of the concrete is supported in this photo, but an unsupported edge just downstream of this support revealed the void seen in Photo 11 and just upstream, an unsupported edge revealed the void seen in Photo 12.

6. Water flowing down the relatively flat concrete spillway and the hill to the right of this spillway has caused erosion to the right of the concrete spillway. The owner may wish to consult a professional engineer for a feasible solution to this condition.

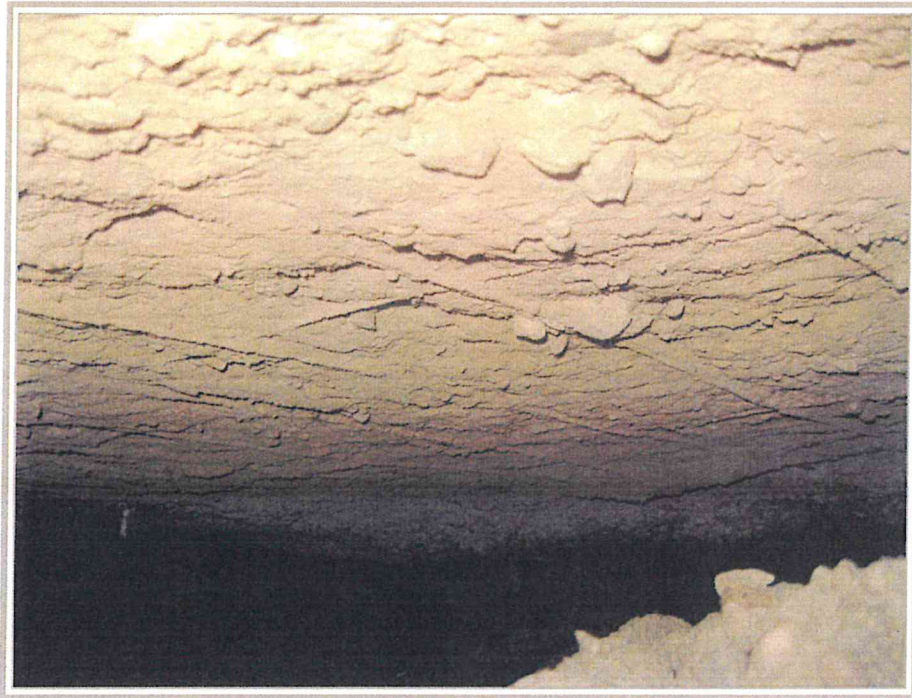
Photo 11 - Void beneath the concrete right spillway. Note the rectangular pattern of what looks to be exposed rebar.

2. It is strongly recommended that the voids under the concrete spillway be immediately addressed. A professional engineer should be consulted for feasible solutions to this condition. Support for the concrete will eventually not be enough, and the spillway will collapse. This repair will be more effective if proper spillway sizing is taken into account by your engineer (see Rec. #10).

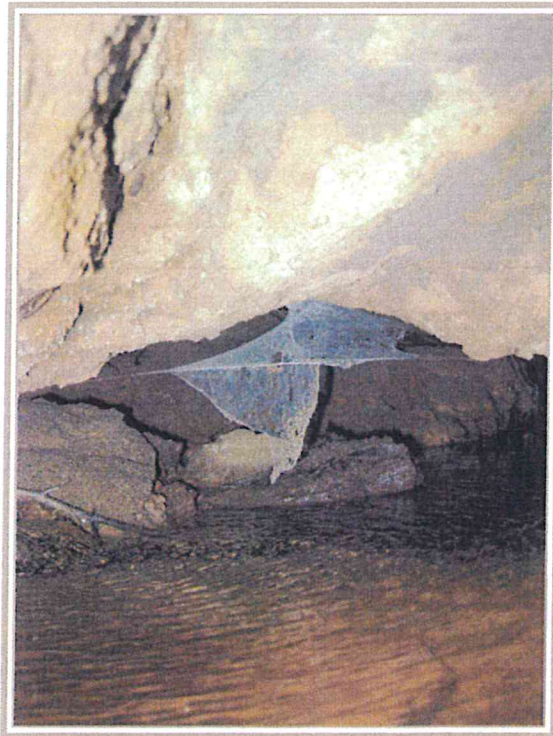
Photo 12 - Void beneath the concrete of the right spillway.
